## Errata Sheet V1.0

AT91  
ARM<sup>®</sup> Thumb<sup>®</sup>  
Microcontrollers

AT91M42800A  
Errata Sheet  
V1.0

Rev. 1782B-01/02

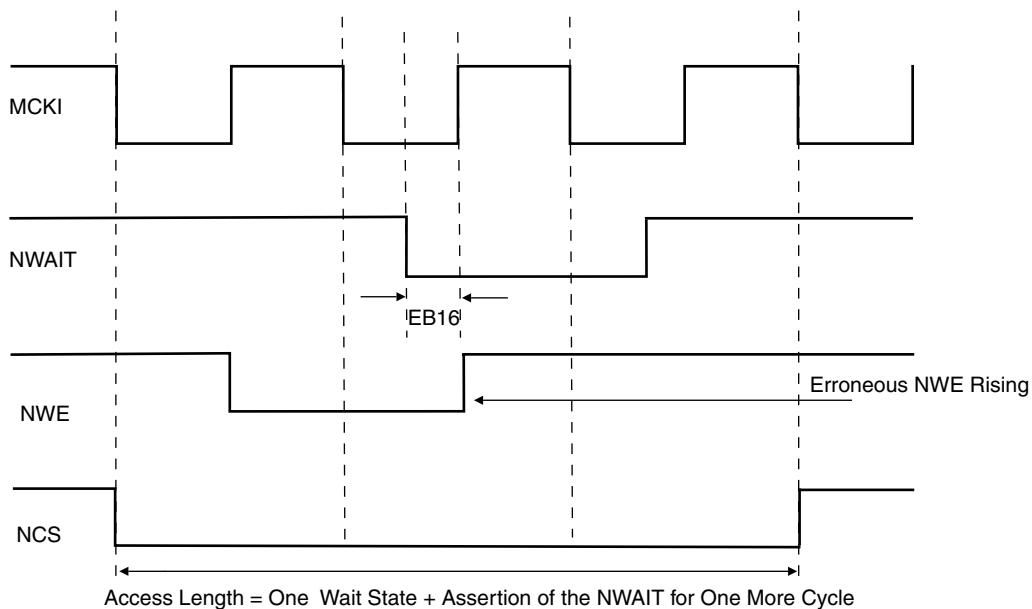
**Figure 4.** Description of the Number of Standard Wait States

If the first two conditions are not met during write accesses, the NWE signal is not affected by the NWAIT assertion. The following example illustrates the number of standard wait states. NWAIT is not asserted during the first cycle, but is asserted at the second and last cycle of the standard access. The access is correctly delayed as the NCS line rises accordingly to the NWAIT assertion. However, the NWE signal waveform is unchanged, and rises too early.
