Errata Sheet V1.0

Internal Product
Reference 56515B

AT91M558800A-33AI
AT91M55800A-33CI

AT91M55800A Errata Sheet V1.0

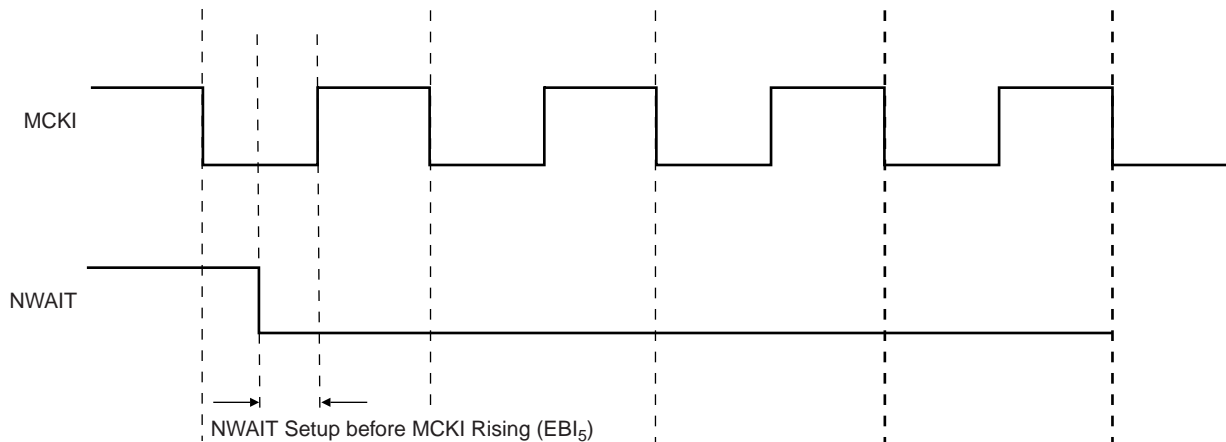
Figure 1. NWAIT Rising

If the NWAIT setup time is satisfied on the first rising edge of MCKI, the behavior is accurate. The EBI operations are not affected when the NWAIT rises.

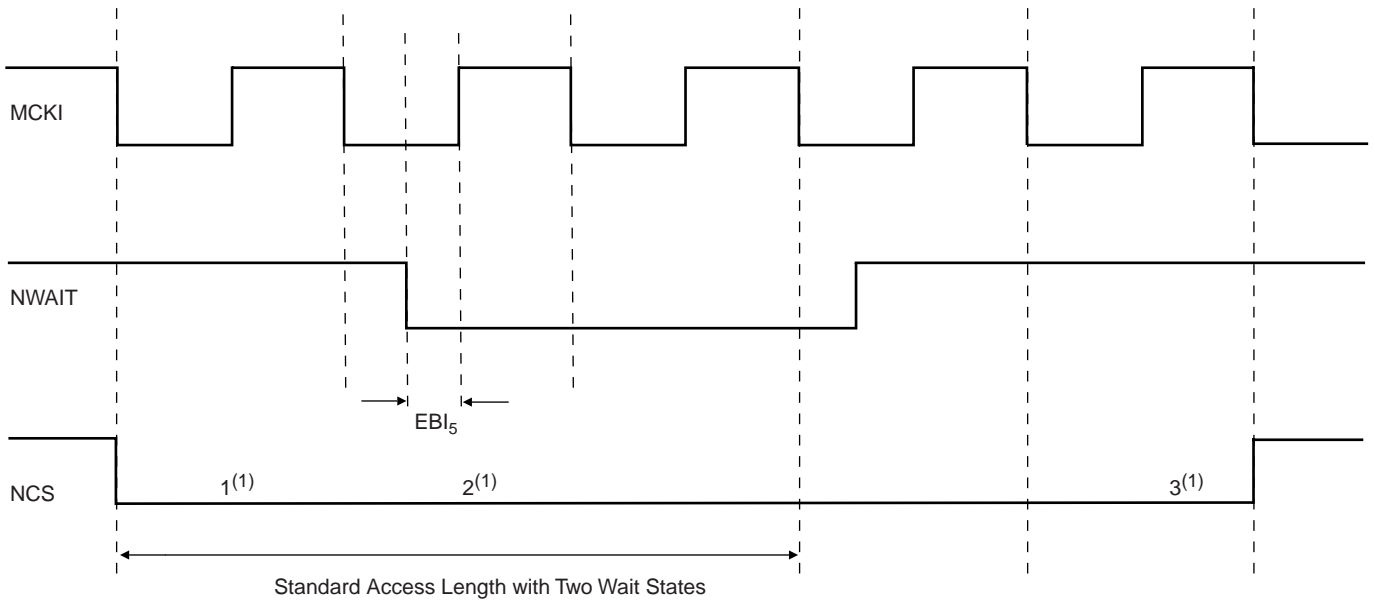
Figure 2. Number of Standard Wait States is Two

If the NWAIT setup time is satisfied on the following edges of MCKI and if at least one standard wait state remains to be executed, the behavior is accurate. In the following example, the number of standard wait states is two. The NWAIT setup time on the second rising edge of MCKI must be met.

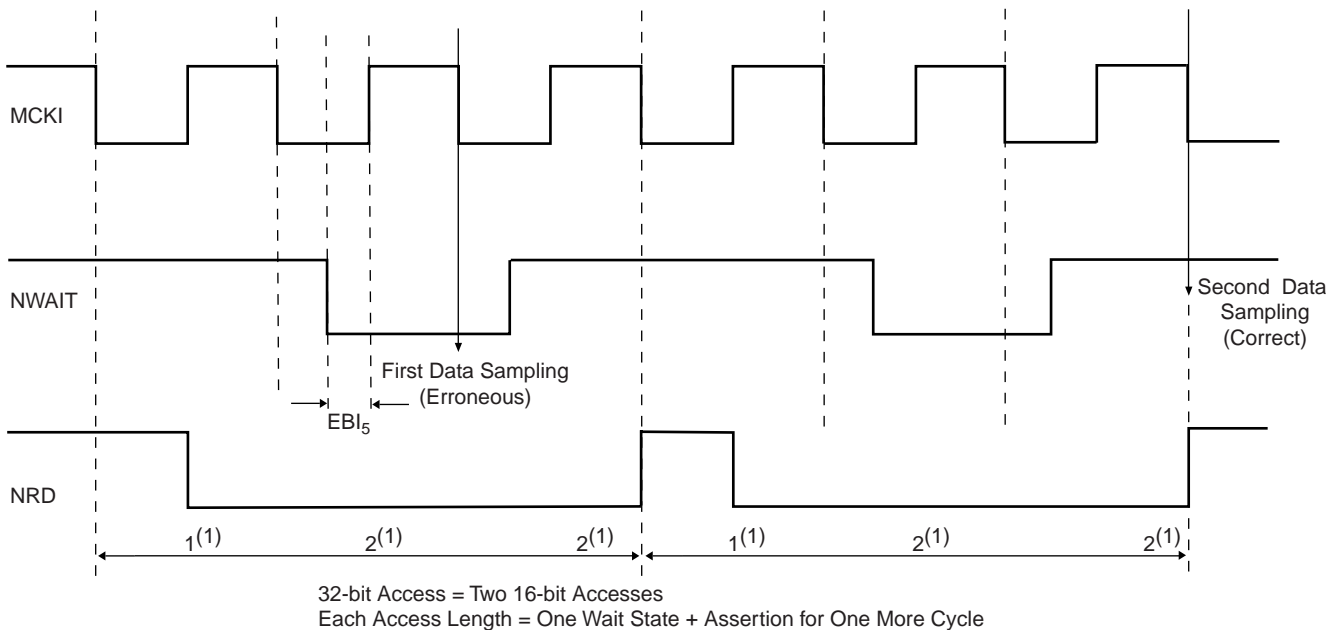
Figure 3. Number of Standard Wait States is One

If the first two conditions are not met during a 32-bit read access, the first 16-bit data is read at the end of the standard 16-bit read access. In the following example, the number of standard waits is one. NWAIT assertions do affect both NRD pulse lengths, but first data sampling is not delayed. The second data sampling is correct.

At maximum speed, asserting the NWAIT in the first access cycle is not possible, as the sum of the timings “MCKI Falling to Chip Select” and “NWAIT setup to MCKI rising” are generally higher than one half of a clock period. This leads to using at least one standard wait state. However, this is not sufficient except to perform byte or half-word read accesses. Word and write accesses require at least two standard wait states.

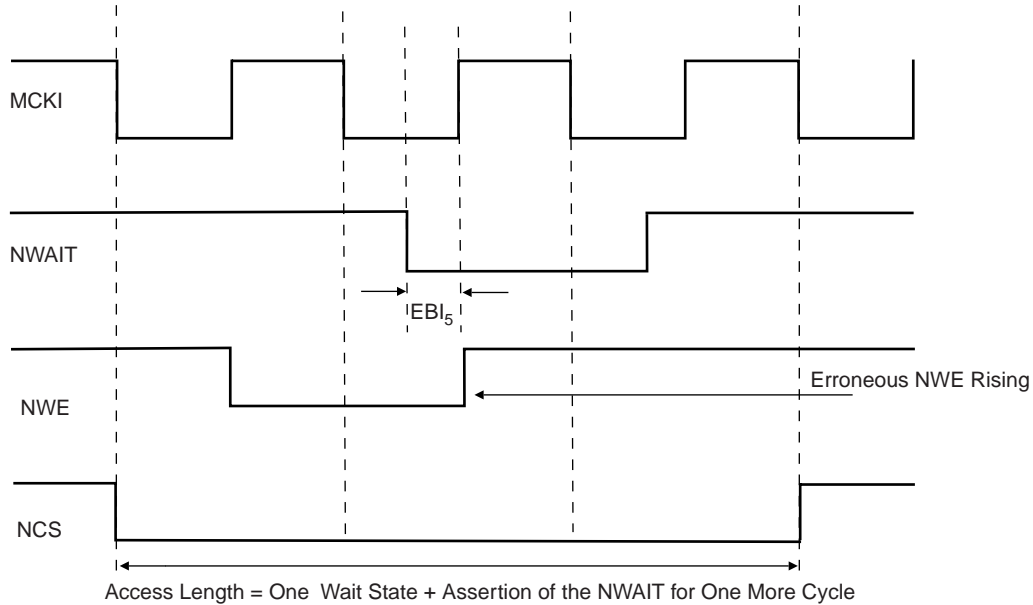
Figure 4. Description of the Number of Standard Wait States

If the first two conditions are not met during write accesses, the NWE signal is not affected by the NWAIT assertion. The following example illustrates the number of standard wait states. NWAIT is not asserted during the first cycle, but is asserted at the second and last cycle of the standard access. The access is correctly delayed as the NCS line rises accordingly to the NWAIT assertion. However, the NWE signal waveform is unchanged, and rises too early.
