CAN Microcontrollers

T89C51CC01
T89C51CC01UA
T89C51CC01CA

Errata Sheet

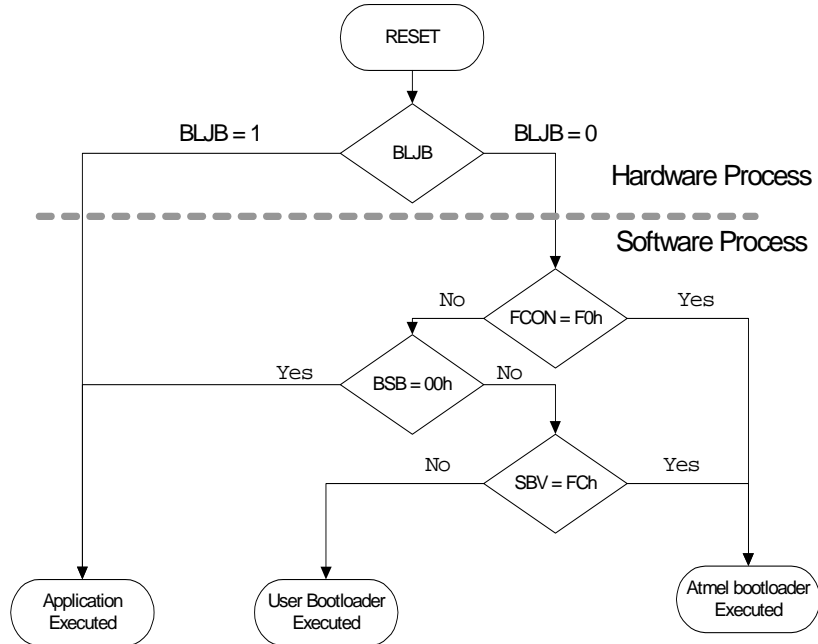
Version 1.2:

4. Boot Process Compatibility

There are some differences between Boot process of bootloader 1.2 and newer versions (see below).

Use the fuse bit BLJB to start the application in both versions.
